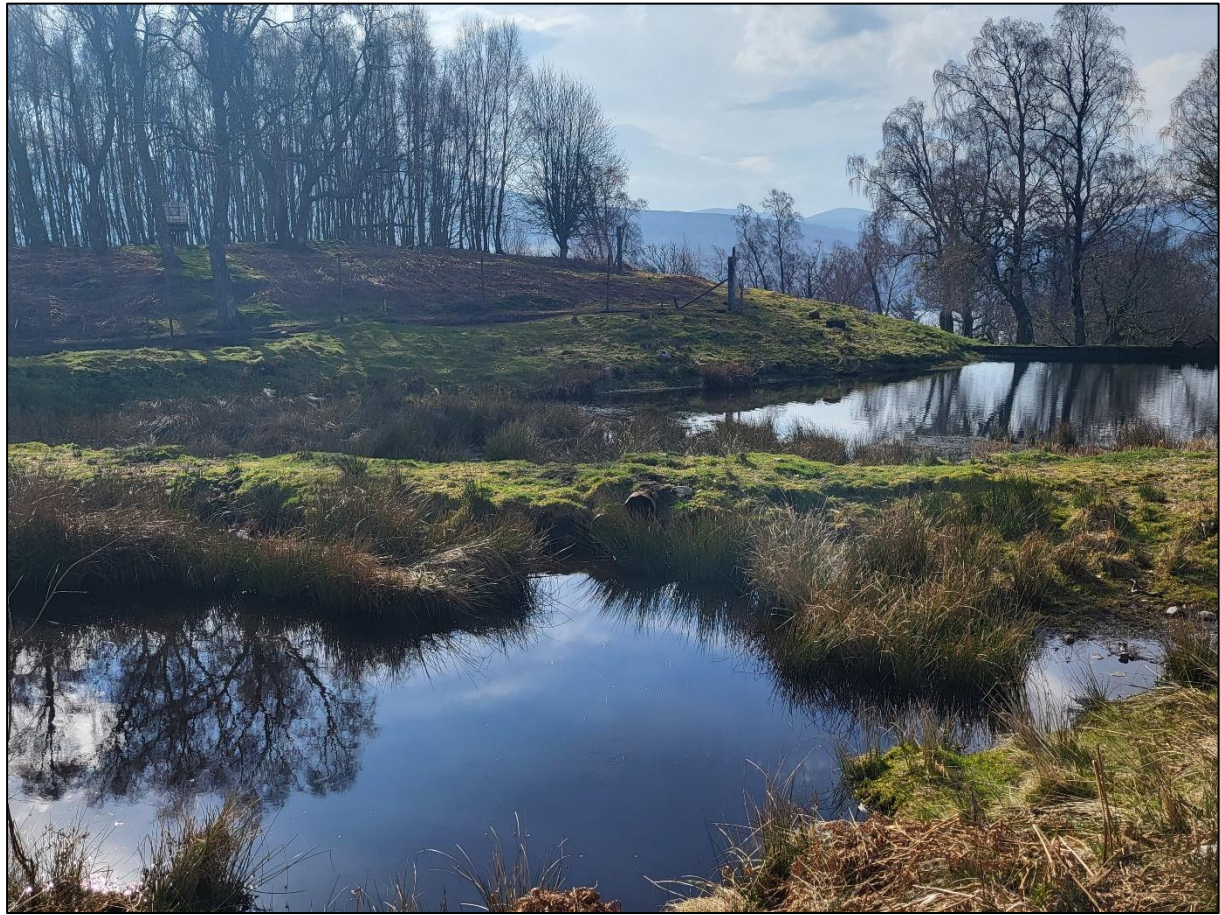
Downstream Viewpoint

**Photograph Sheet:** 01  
**NGR:** NH 33584 63827  
**Photograph Date:** 21/03/2025  
**Description:** View of dammed ponds, which drain to Loch Luichart. Ponds are situated downstream of location shown on Photograph Sheet 03 and culverted allowing flow between the locations.

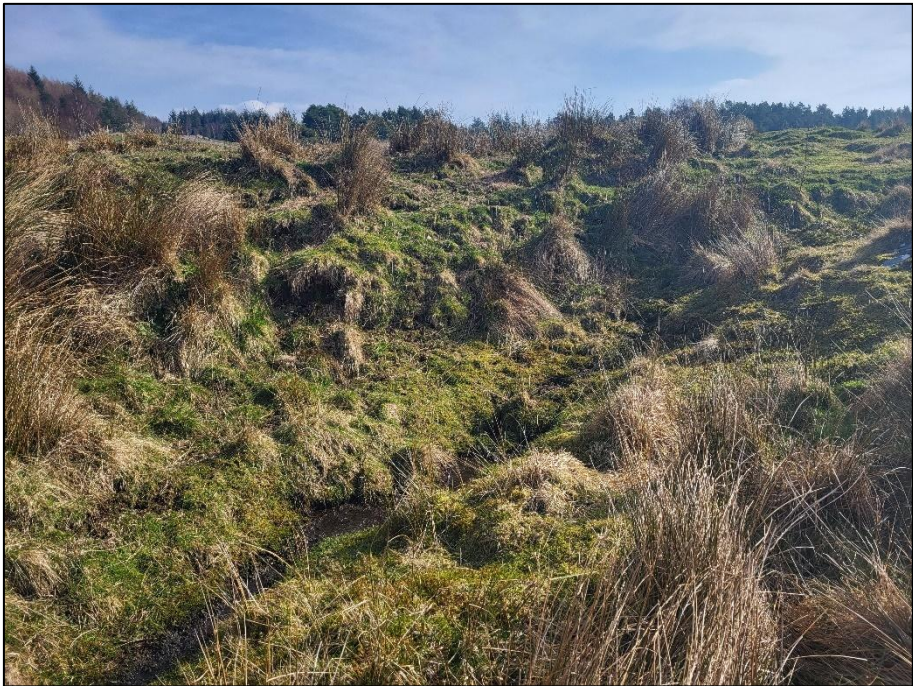
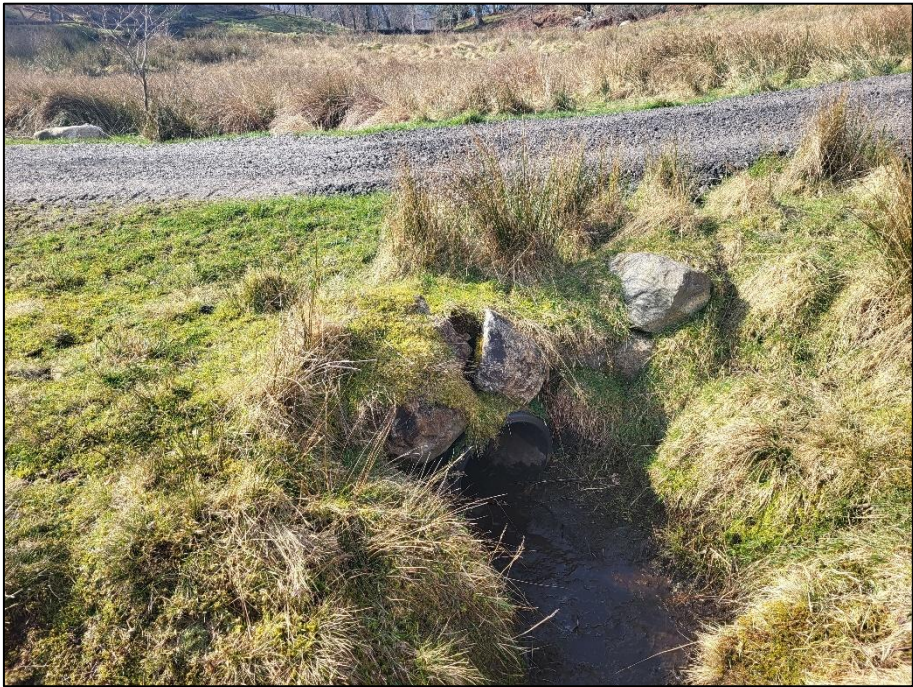
**Photograph Sheet:** 02  
**NGR:** NH 33614 63831  
**Photograph Date:** 21/03/2025  
**Description:** Culverted watercourse under track to pond. Vegetation throughout banks, left bank c.0.08m, right bank c.0.8m, width c.0.7m, water depth c.0.01m. The channel substrate is predominantly sand and silt.

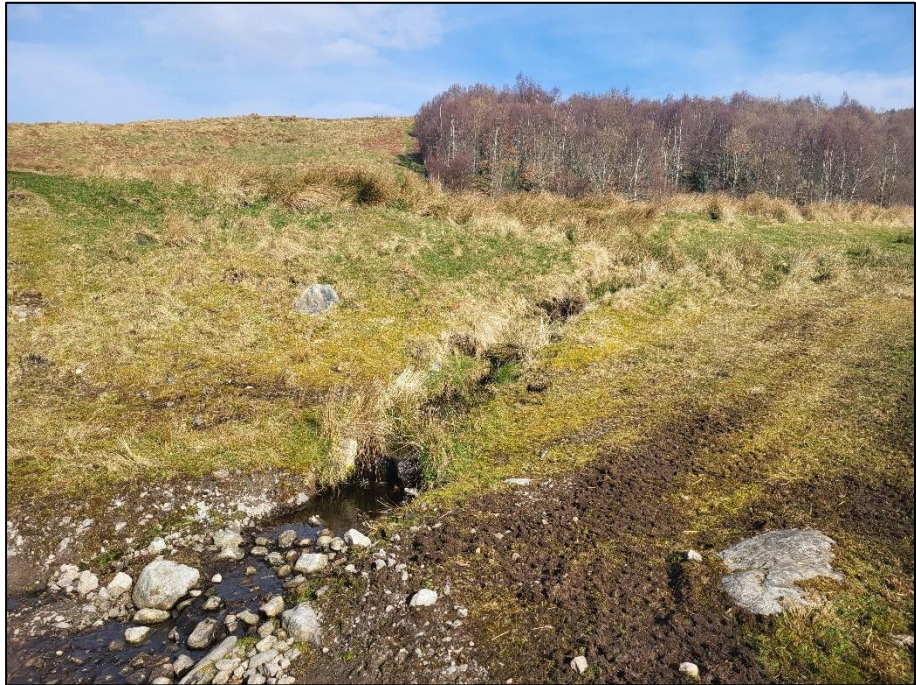
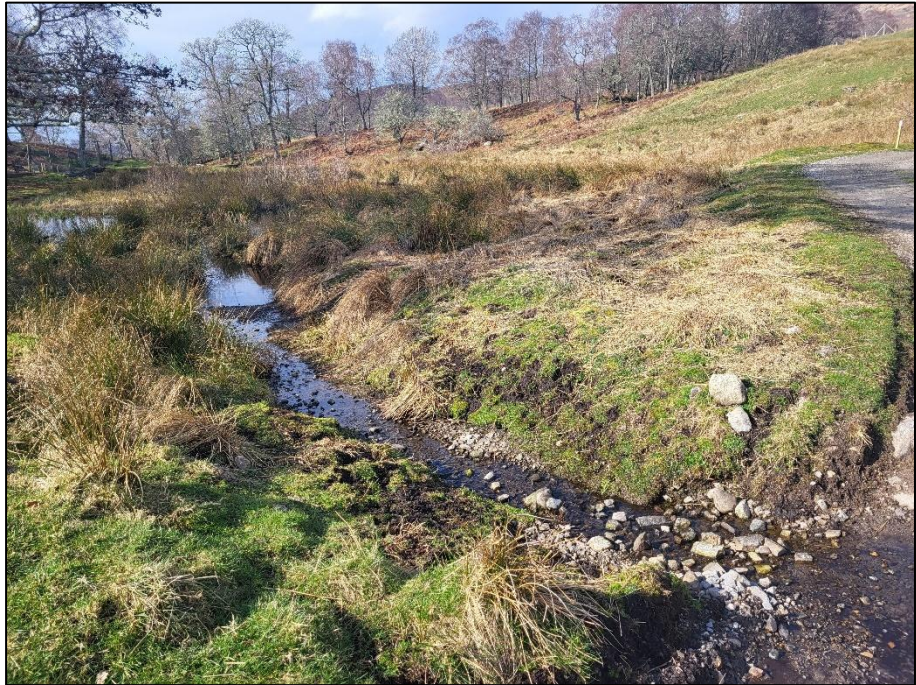
**Photograph Sheet:** 03  
**NGR:** NH 33653 63823  
**Photograph Date:** 21/03/2025  
**Description:** Watercourse flowing across the track into the pond on Photograph Sheet 01. The left bank is c.0.1m, right bank c.0.2m, width c.0.8m, water depth c.0.07m. The channel substrate is predominantly pebbles, cobbles, and boulders.

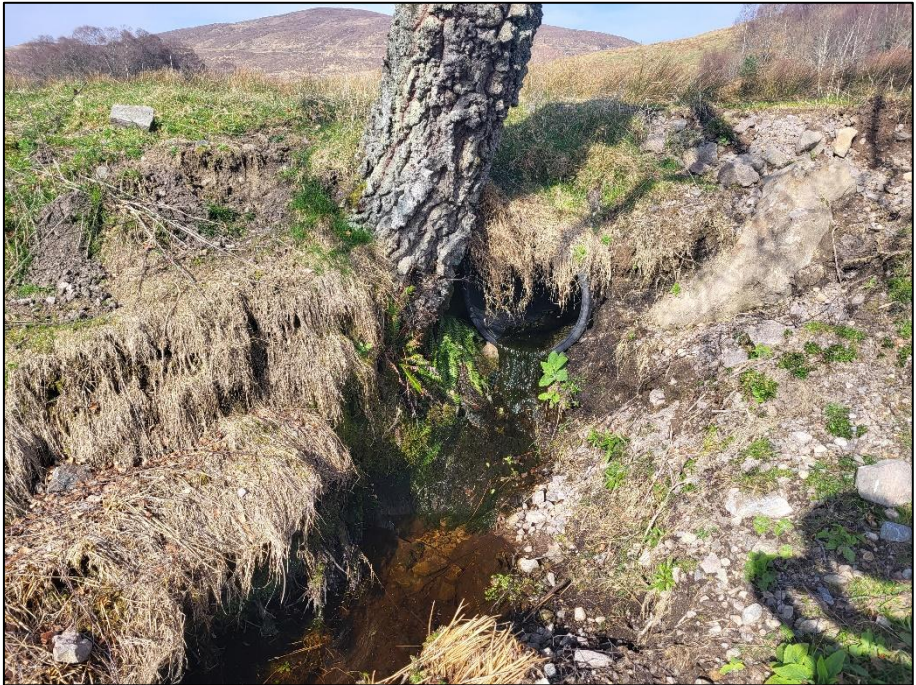
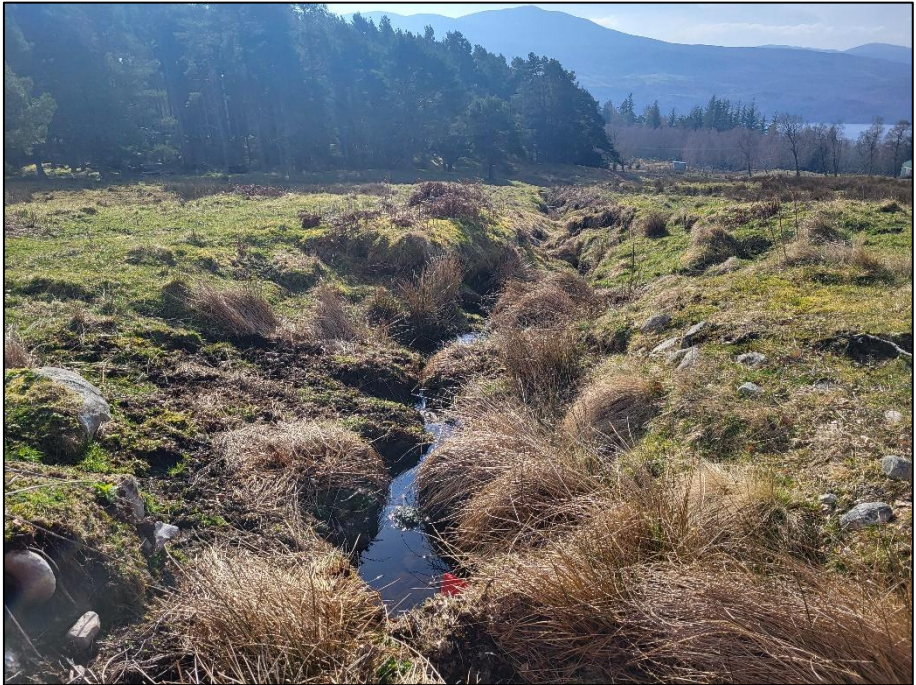
**Photograph Sheet:** 04  
**NGR:** NH 33734 63806  
**Photograph Date:** 21/03/2025  
**Description:** Culverted watercourse through the access track. The left bank is c.0.5m, right bank c.0.7m, width c.0.6m, water depth c.0.3m. The channel substrate is predominantly pebbles, cobbles, and boulders.

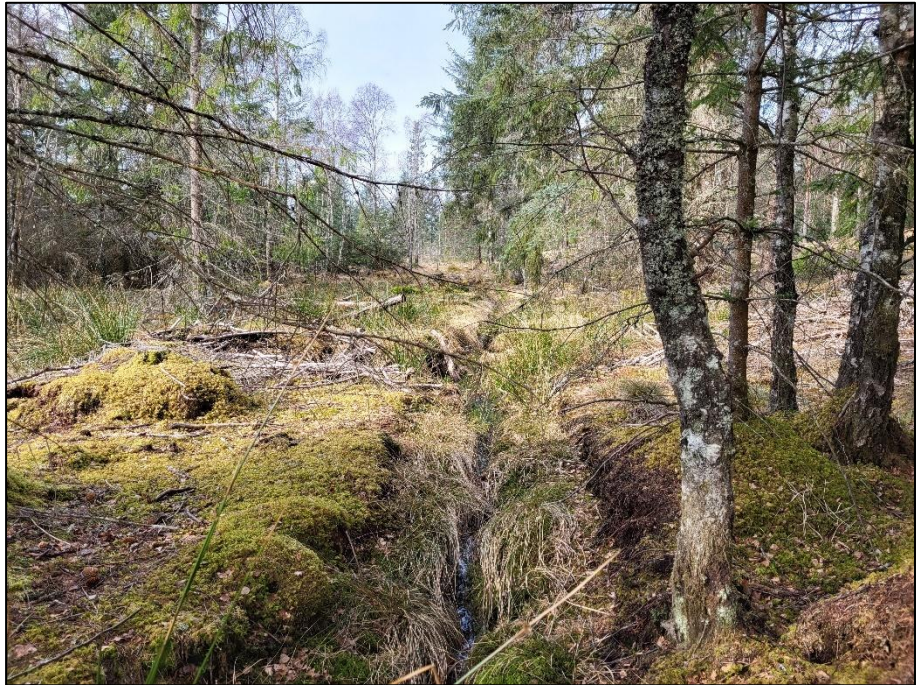
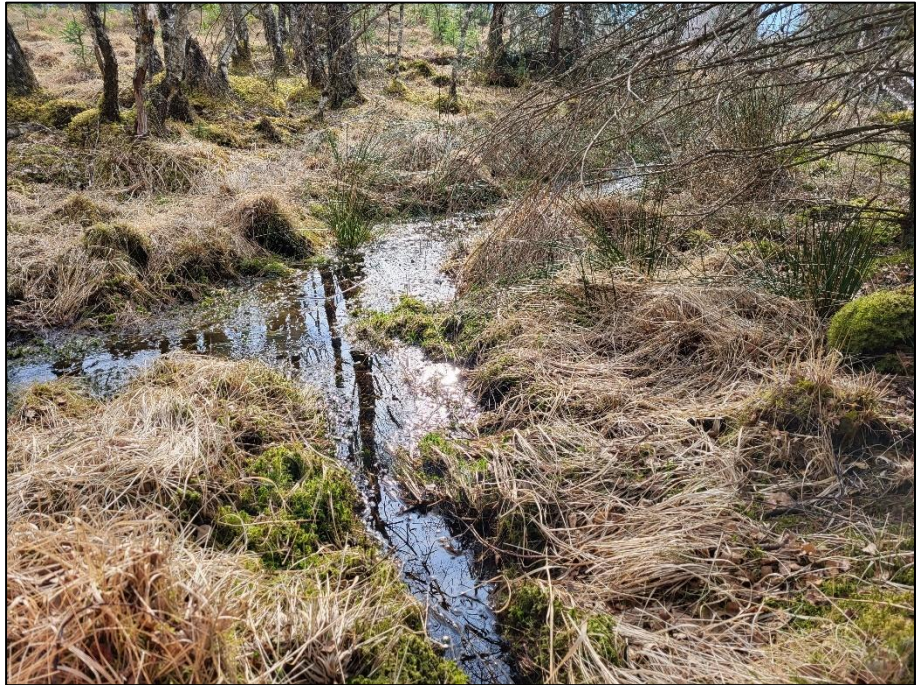
**Photograph Sheet:** 05  
**NGR:** NH 34251 63861  
**Photograph Date:** 21/03/2025  
**Description:** Watercourse upstream of Photograph Sheet 06. The left bank is c.0.1m, right bank c.0.1m, width c.0.2m, water depth c.0.06m. The channel substrate is predominantly earth.

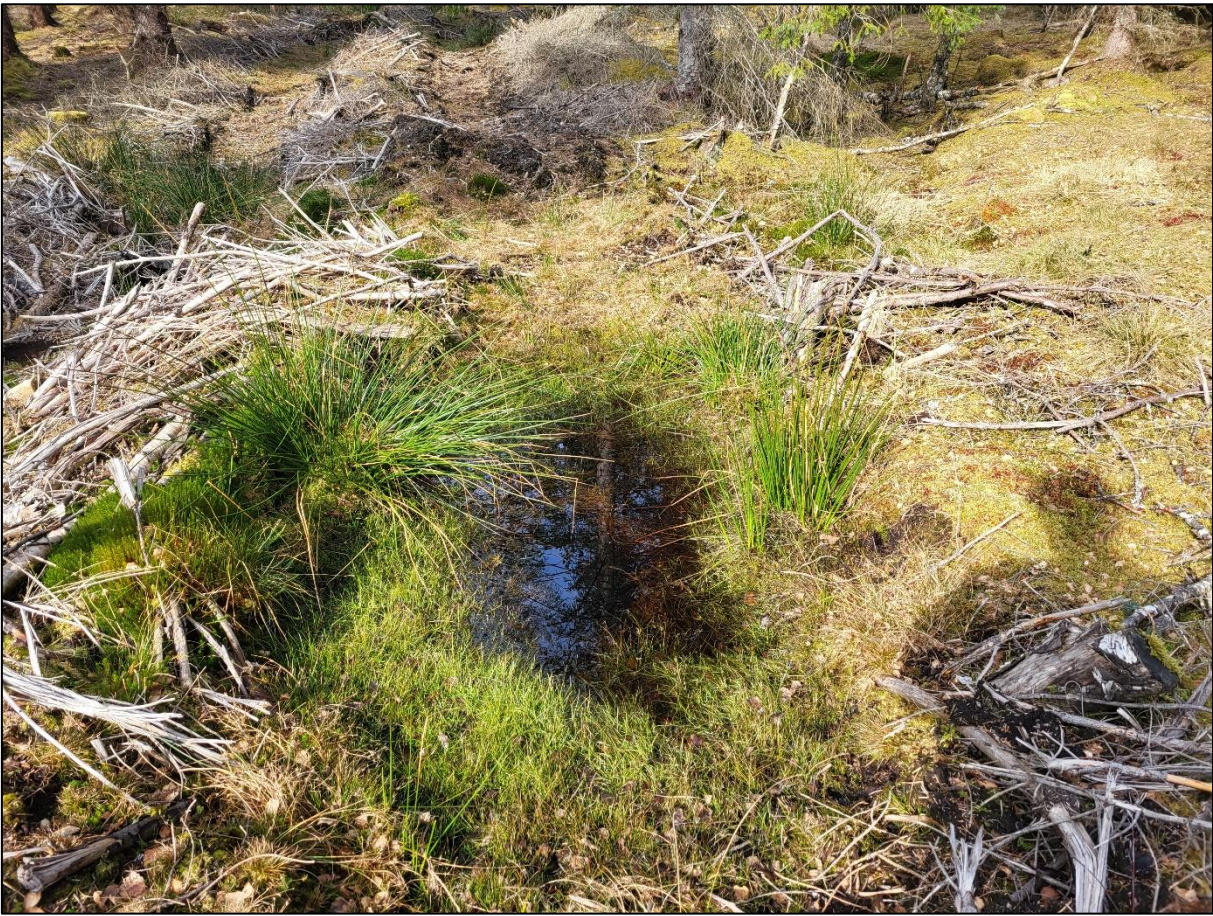
Upstream Viewpoint

**Photograph Sheet:** 06  
**NGR:** NH 33584 63827  
**Photograph Date:** 21/03/2025  
**Description:** View of pond adjacent to Photograph Sheet 05.

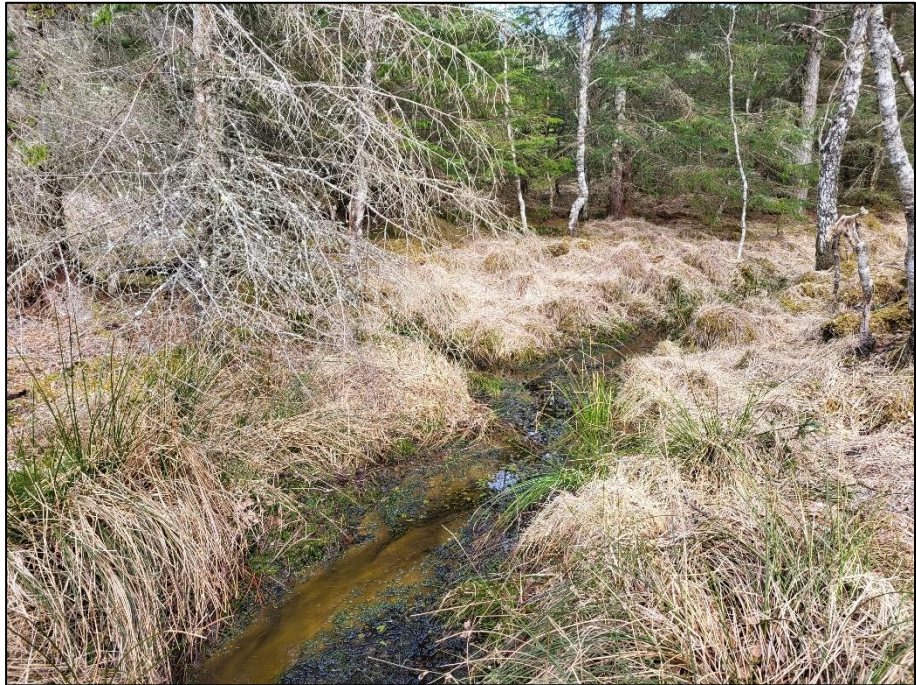
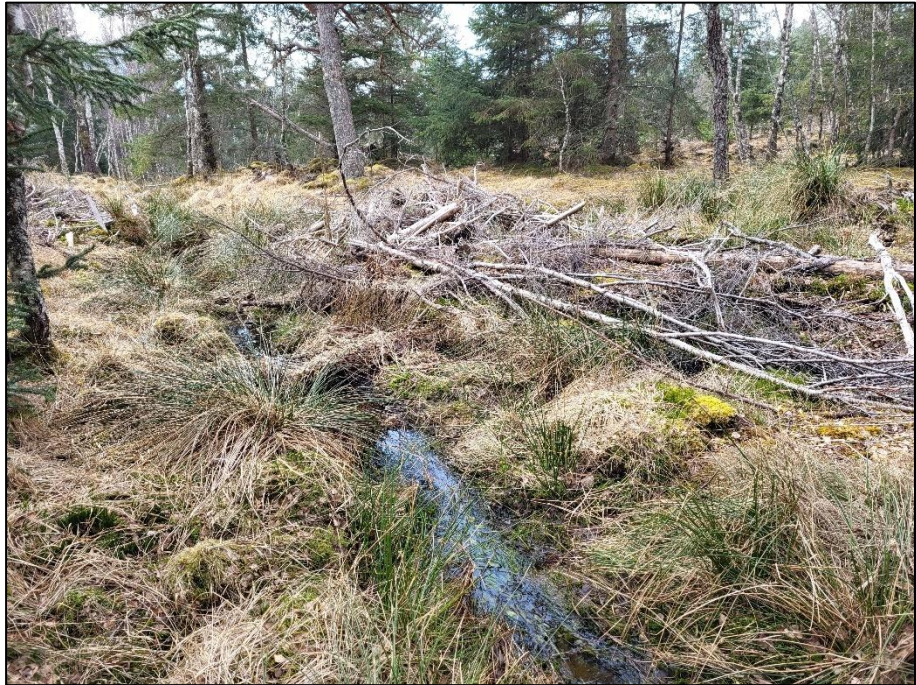
**Photograph Sheet:** 07  
**NGR:** NH 24251 63849  
**Photograph Date:** 21/03/2025  
**Description:** Location of the watercourse crossing. The left bank is c.0.05m, right bank c.0.04m, width c.0.4m, water depth c.0.3m. The channel substrate is predominantly earth and silt. Flow speed is 0.002l/s.

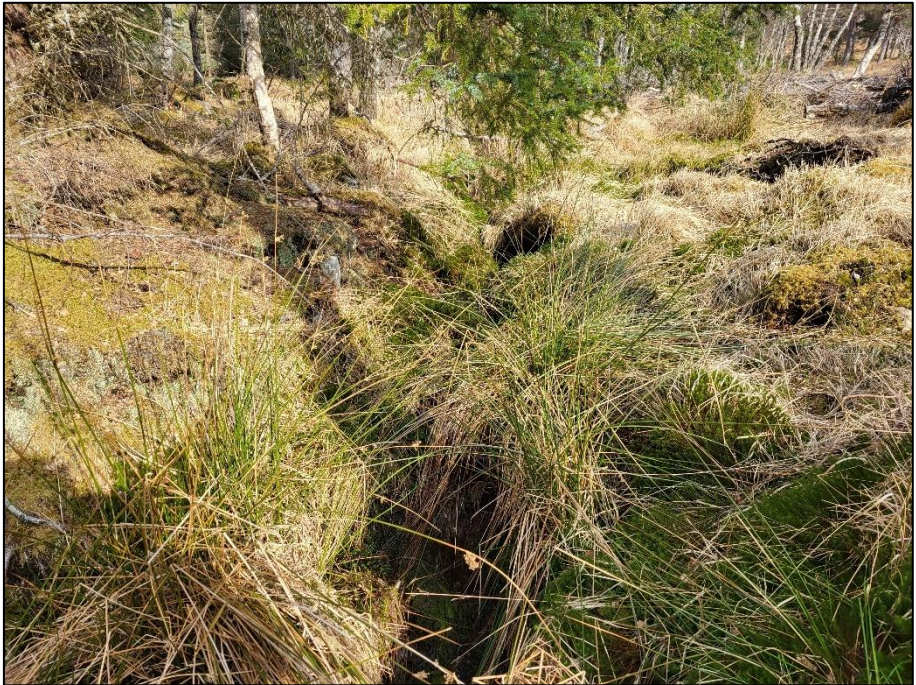
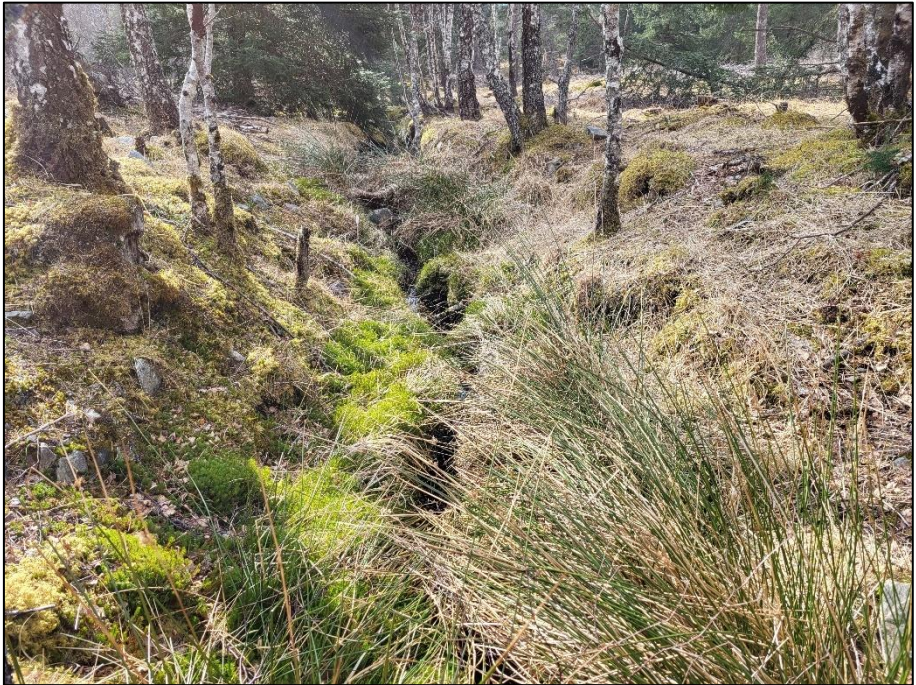
**Photograph Sheet:** 08  
**NGR:** NH 34255 63823  
**Photograph Date:** 21/03/2025  
**Description:** Downstream of the watercourse crossing (Photograph Sheet 06). The left bank is c.0.2m, right bank c.0.2m, width c.0.2m, water depth c.0.08m. The channel substrate is predominantly silt.

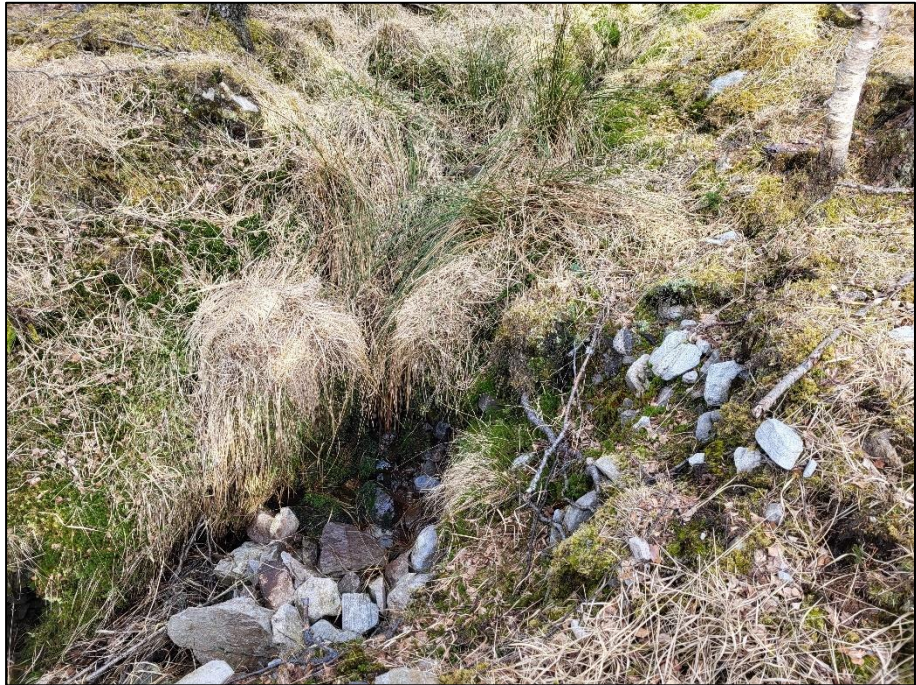
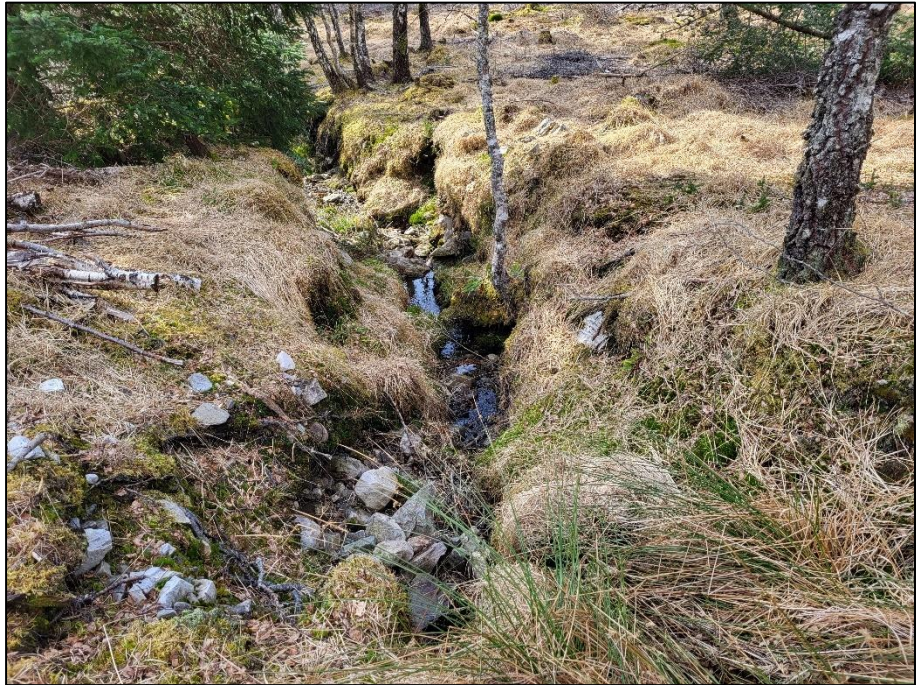
**Photograph Sheet:** 09  
**NGR:** NH 33725 63764  
**Photograph Date:** 21/03/2025  
**Description:** Downstream of Photograph Sheet 07. The left bank is c.0.8m, right bank c.0.8m, width c.1.0m, water depth c.0.08m. The channel substrate is predominantly cobbles and boulders.

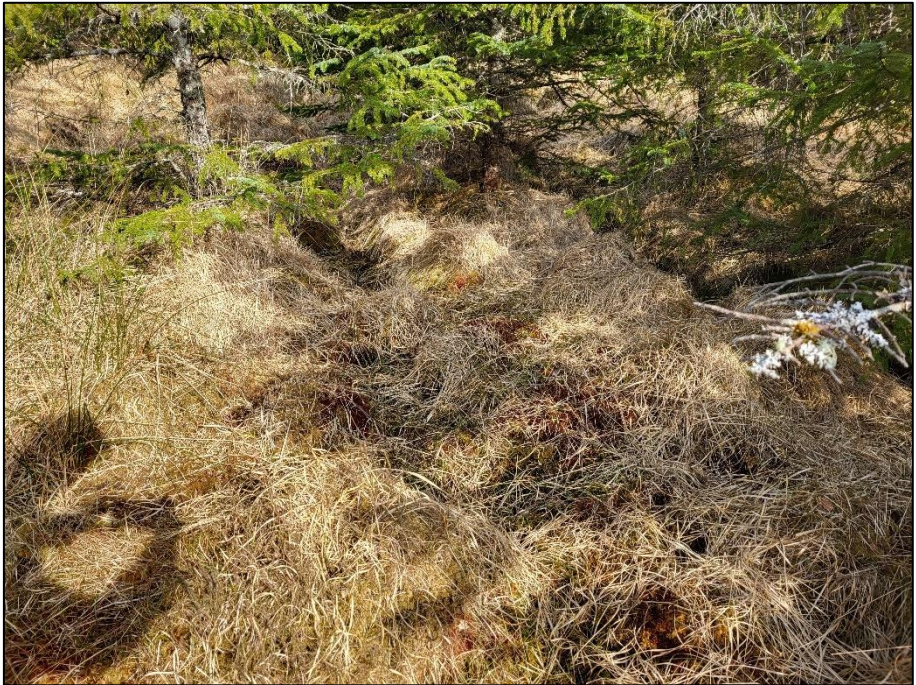
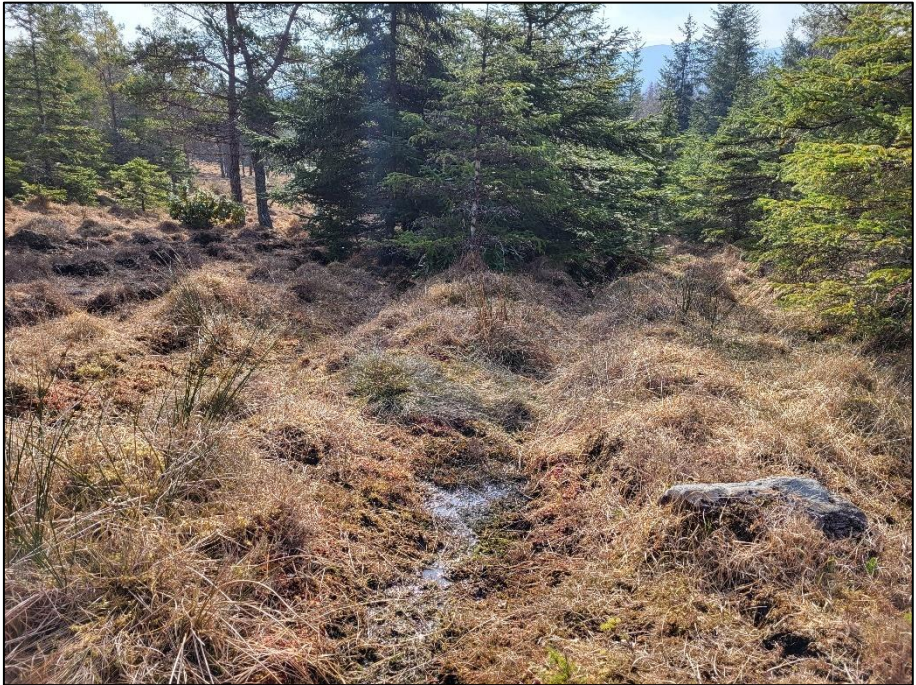
**Photograph Sheet:** 10  
**NGR:** NH 33810 63600  
**Photograph Date:** 21/03/2025  
**Description:** Watercourse south of the proposed attenuation basin. The left bank is c.0.01m, right bank c.0.01m, width c.0.08m, water depth c.0.01m.

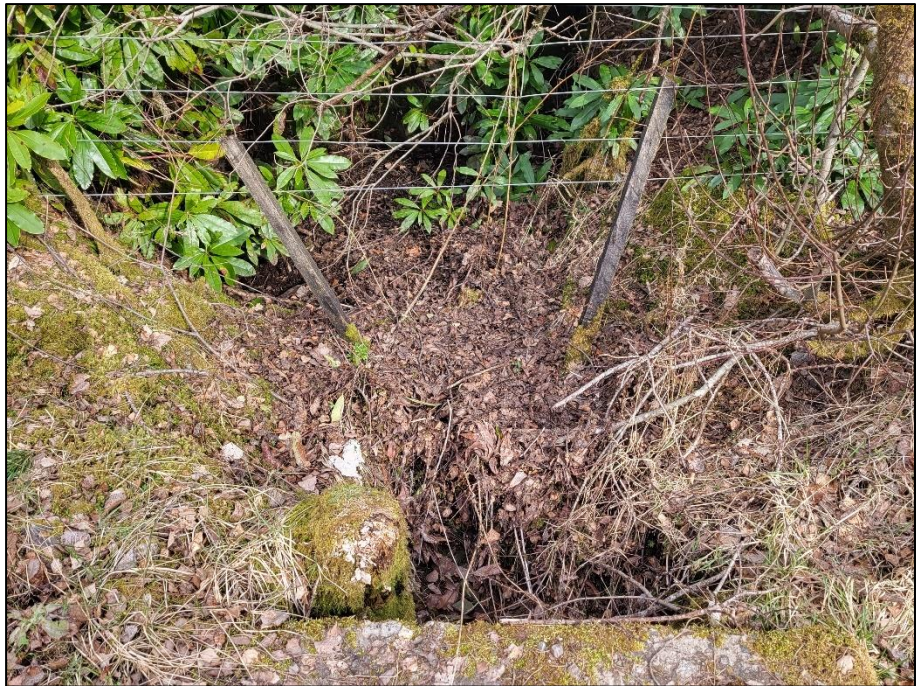
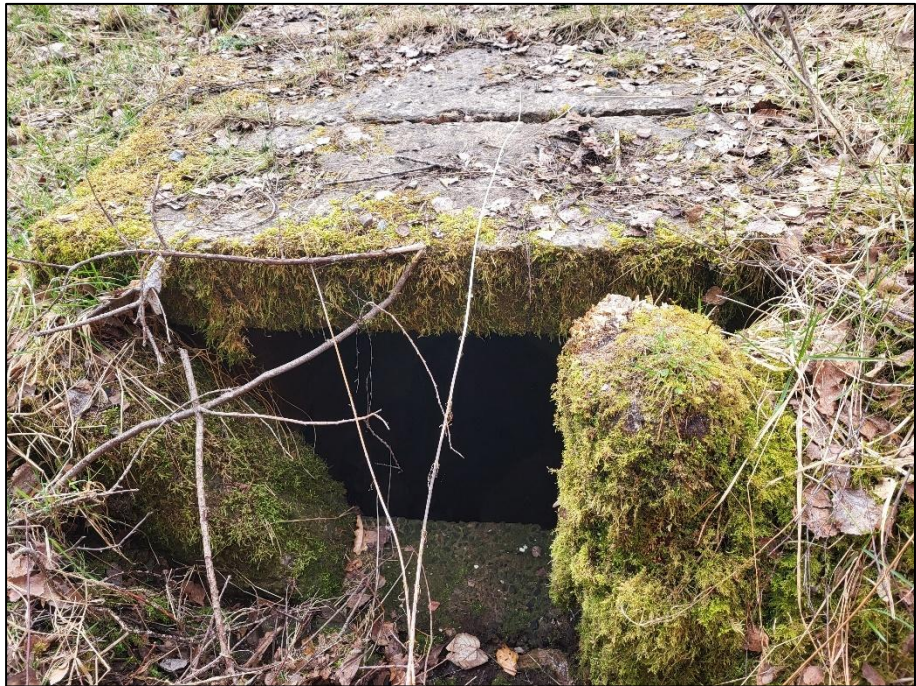
Photograph Sheet:	11
NGR:	NH 33653 63456
Photograph Date:	21/03/2025
Description:	Watercourse culverted under the road (A832). The left bank is c.0.07m, right bank c.0.06m, width c.0.4m, no water present in channel. Banks comprise of earth and laid stone. The channel substrate predominantly earth.
